Baxter

Urgent Product Recall

RE: COLLEAGUE VOLUMETRIC INFUSION PUMP, PRODUCT CODES 2M8151
2M8151R, 2M8161, 2M8161R, 2M8153, 2M8153R, 2M8163, 2M8163R

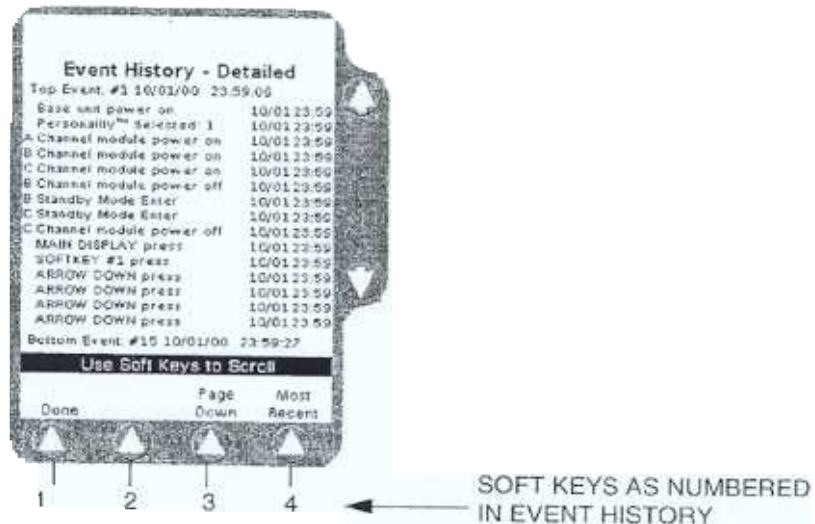
Figure 5-14 Example of Event History Display

The **Event History** option on the **Configuration/Service Menu** lets you view up to 1,000 pump events that have occurred, including key presses.

- Press the **Select** soft key. The **Event History** screen (Figure 5-14) is displayed.
- Use the **Page Up**, **Page Down**, or **Most Recent** soft keys or the $\uparrow\downarrow$ keys to scroll through the event history.
- Press the **Done** soft key to return to the Configuration/Service Menu.

Soft key presses are indicated in the event history by a number (1 through 4) corresponding to the soft keys as shown in Figure 5-14. The function of the soft keys varies depending on the Main Display screen displayed at the time.
